Ref U0008185

[REDACTED]
95 Merton Park Road
Wimbledon
SW19 3PX

95 Merton Hall Road SW19 - CCTV Survey Report : 18/09/15

Inspection Report

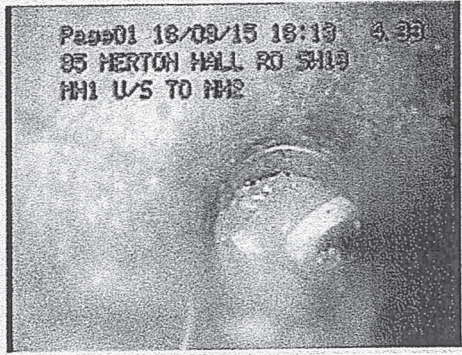
Pos	Code	Description	Image
04.33m	SA	Survey abandoned END	Image Provided - Ref: 1_9999
